Lead-Based Paint Risk Assessment Report

2103 Garfield AVE S A and Common Areas

Paint Inspection / Risk Assessment Summary

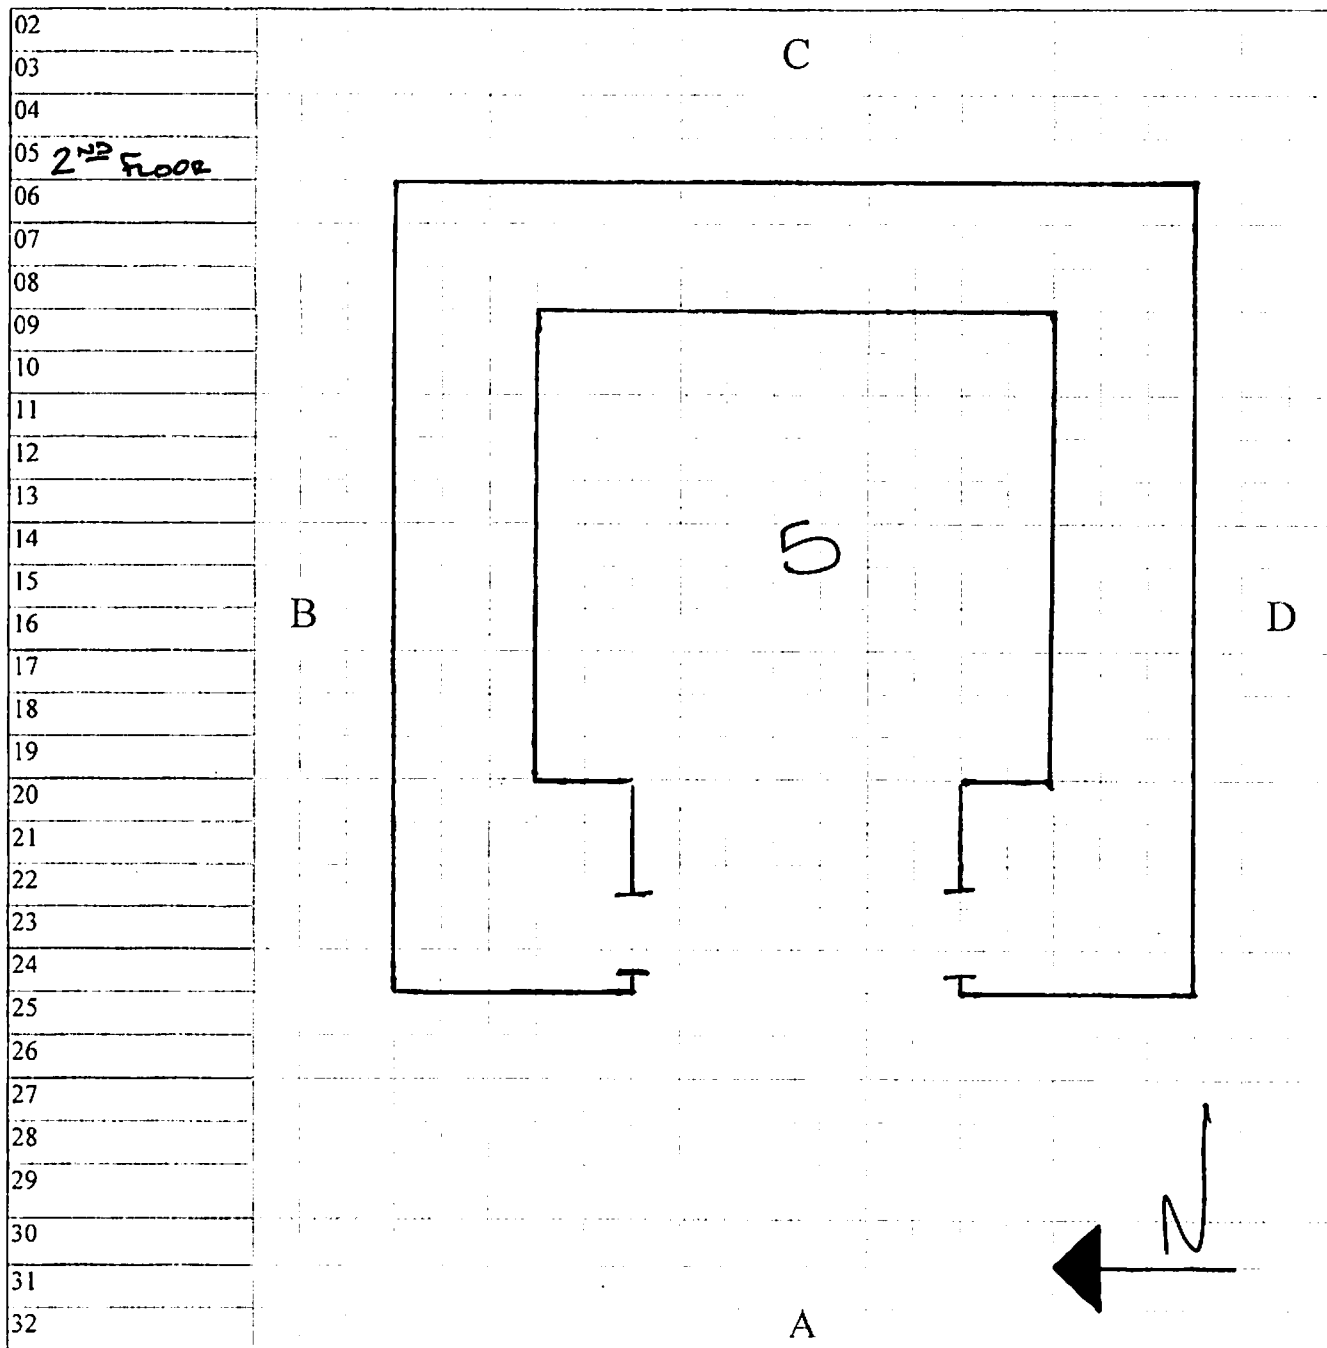
Case Type	Tracking #	Property Address	Dwelling Unit	
EIBLL	10519	2103 Garfield Ave	COMMON	
Risk Assessor	Page Number	Exterior / Floor Level	Drawn By	Date
VOLLMER	Page <u>3</u> of <u>5</u>	SECOND	AIV	12/7/10

City of Minneapolis – Lead Hazard Control – Dwelling Sketch

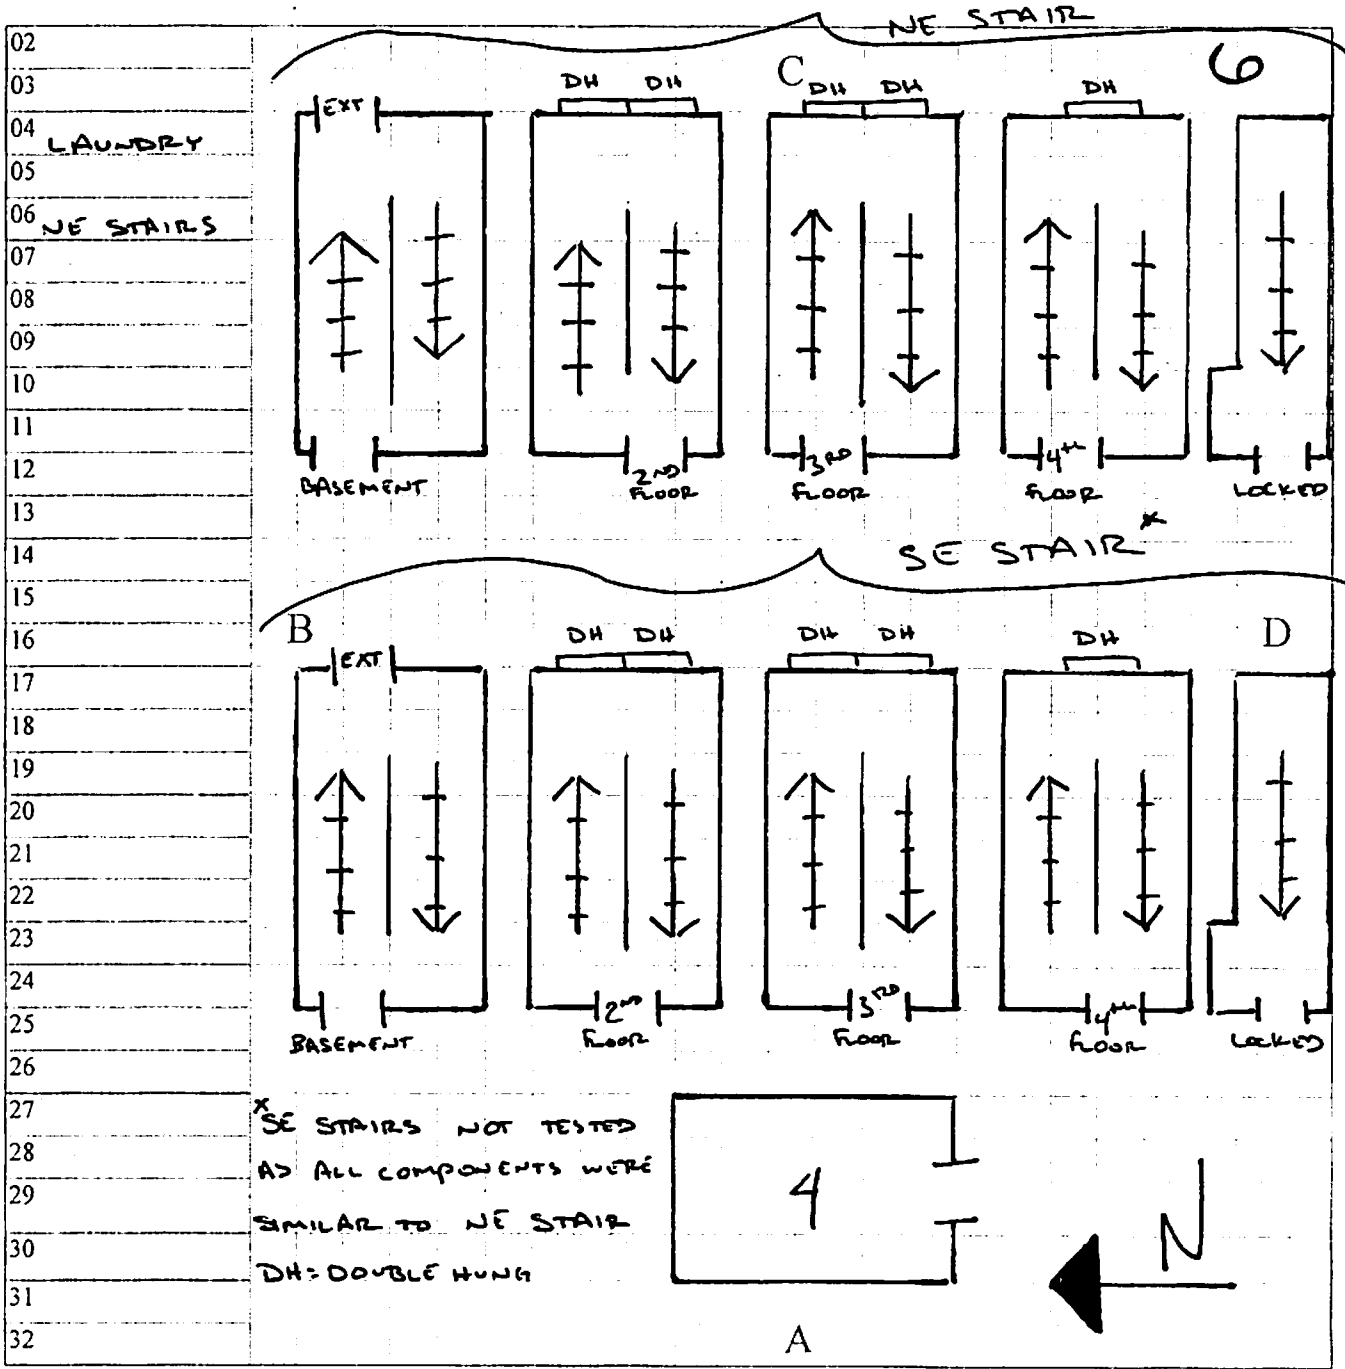
Case Type	Tracking #	Property Address	Dwelling Unit	
EIBLL	10519	2103 Garfield Ave	COMMON	
Risk Assessor	Page Number	Exterior / Floor Level	Drawn By	Date
VOLLMER	Page 4 of 5		AIU	12/7/10

City of Minneapolis – Lead Hazard Control – Dwelling Sketch
