Lead-Based Paint Risk Assessment Report

2508 Pillsbury AVE 205 and Common Areas

City of Minneapolis - Healthy Homes and Lead Hazard Control

Paint Inspection / Risk Assessment Summary

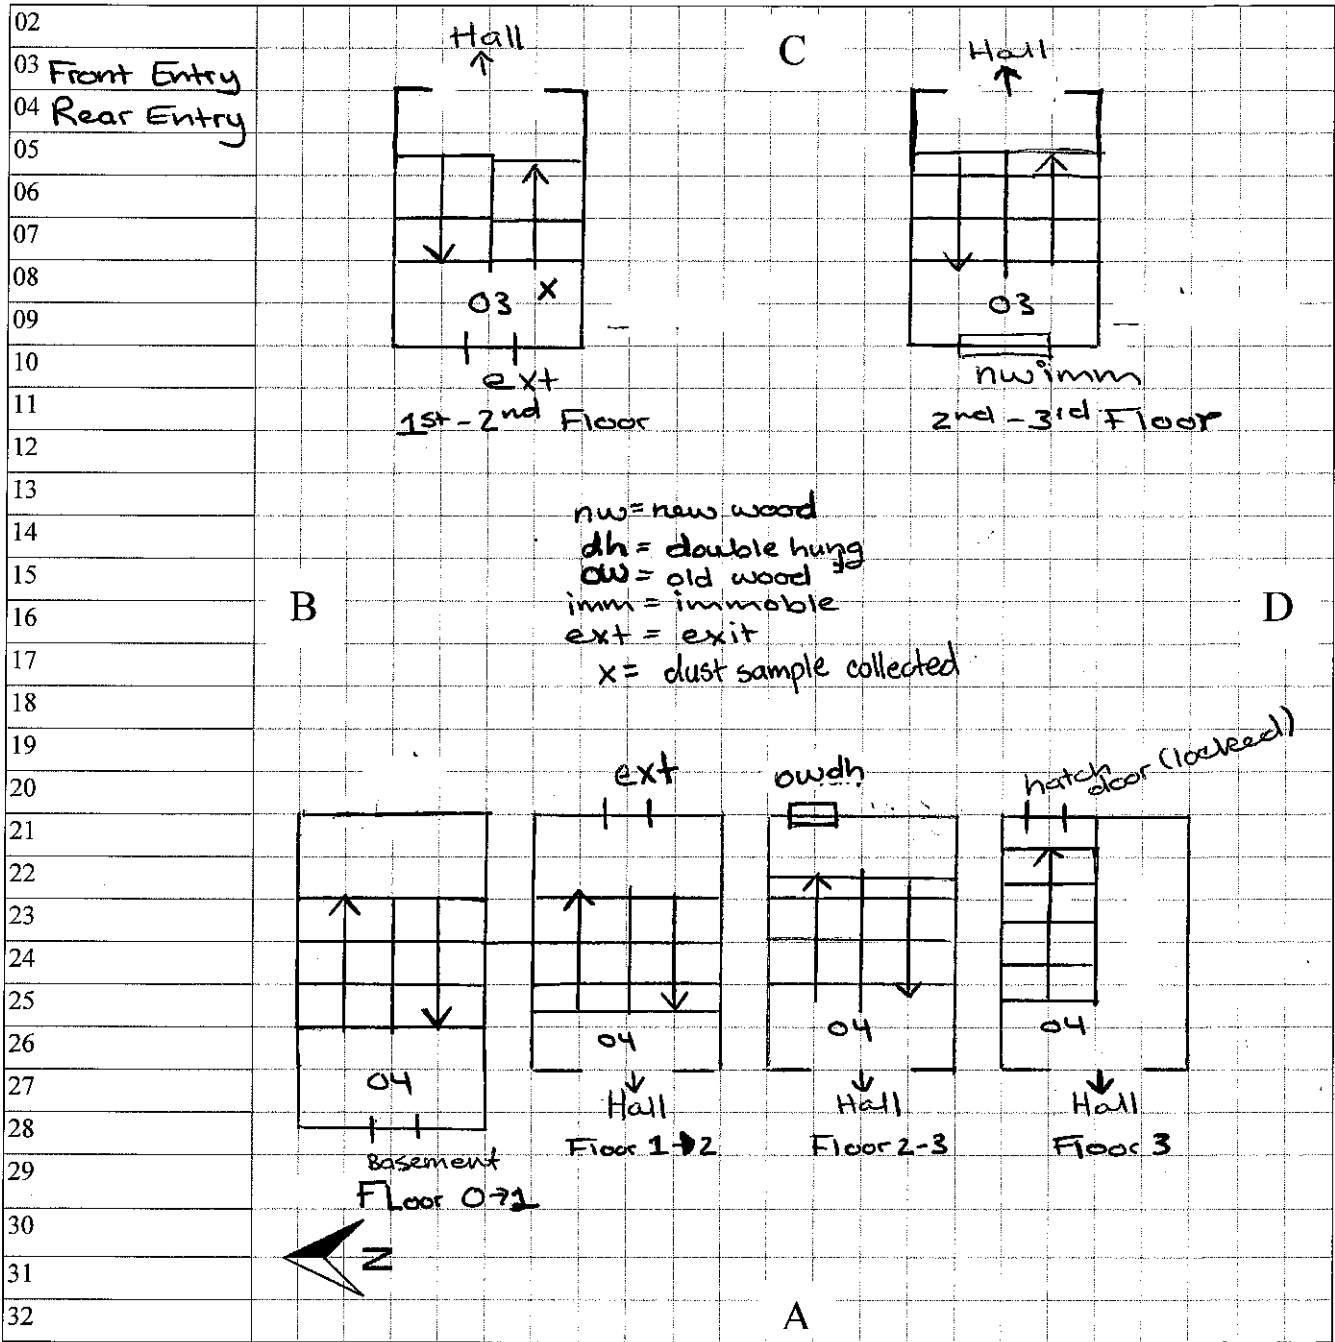
Lead Hazard Control – Dwelling Sketch

Case Type	Tracking #	Property Address	Dwelling Unit	
EBL	13975	2508 Pillsbury Ave	Common	
Risk Assessor	Page Number	Exterior / Floor Level	Drawn By	Date
AH	Page <u>2</u> of <u>5</u>	Basement - 3 rd	AH	12/19/2018

Street used in address of residence: 2508 Pillsbury Ave

This sketch is not to scale.

The sketches include the locations of both lead dust and soil samples that were collected at the Risk Assessment. They are marked on the sketches as follows:

Window sill – WS
Window well – WW
Floor – FW
Soil Sample – SS
